# How Traditional Buildings Perform: 'Breathing Buildings'

Liverpool Wednesday 7th October 2009

Alan Gardner

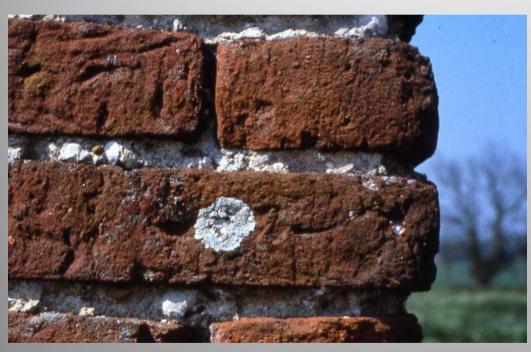
### The Breathing Performance: mortars

- 80% evaporation through the joint zone
- Moisture concentration = accelerated decay through freeze thaw and salt activity.
- Rate of decay?
- Ability to accommodate movement (autogenous properties)

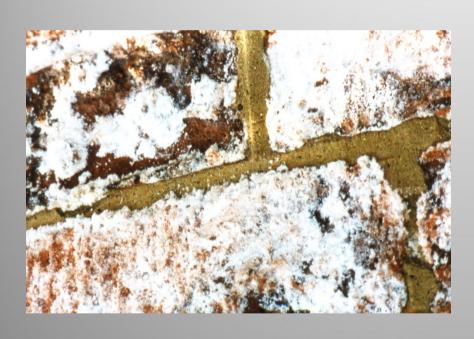
#### Salt Damage/Naming of Parts

- Wetting and drying cycles and the presence of soluble salts creates a build up of pressure
- Particularly damaging to masonry of uniformly distributed fine pores (microporous stone)
- Excessive use of water mobilises embedded salts
- Hygroscopic salts increases 'air dry' or natural content (relate to free or capillary moisture)

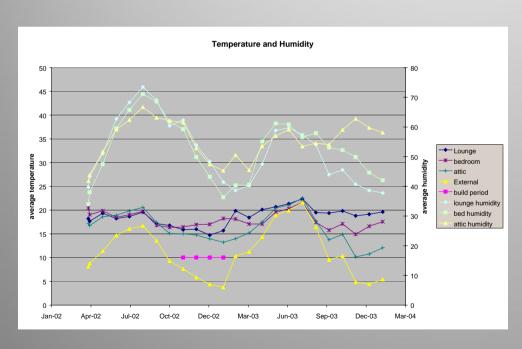
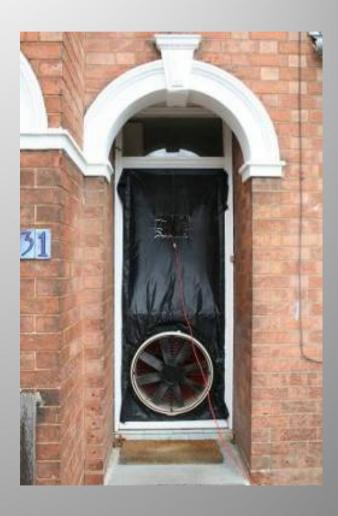
#### Thermal performance/performance in use

Data Logging
Fuel bills
Fan pressurisation
tests

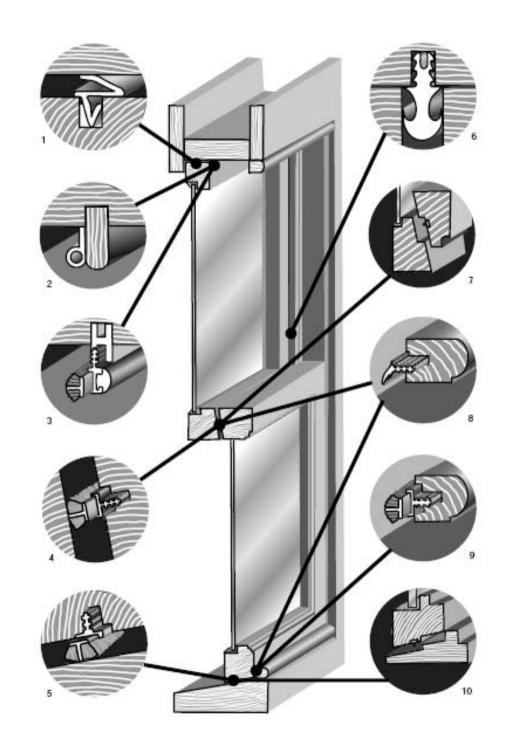
#### Draught-proof

- Repair first
- Can bring 60 75% of savings of double glazing
